Reflective Cracking Testing Notes

Date: March 13, 2017

Project: Reflective Cracking Indoor Phase 5

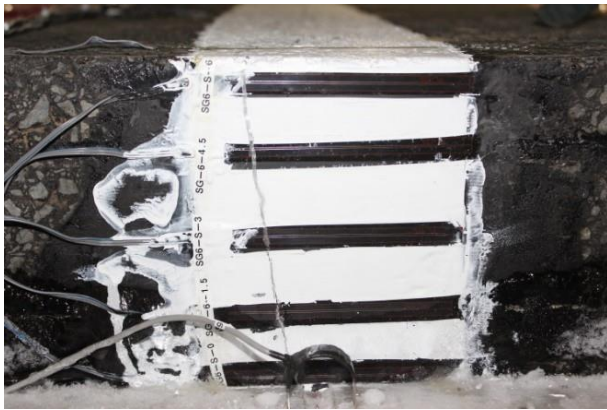
- Outer vertical edge:
 - No visual changes were observed.
 - The outer vertical edge is fully cracked as shown in Figure 1.
 - The 5 vertical edge surface gauges are reading open.
- Joint surface area:
 - The last bit of surface area leading to the inner vertical edge appears to have cracked as shown in Figure 2.
 - The four joint area surface gauges are reading open.
- Inner vertical edge:
 - The upper half of the inner vertical edge is now fully cracked as shown in Figure 3.
 - The five vertical edge gauges are reading open as shown in Figure 4.

Figure 1. South outer vertical edge crack complete.

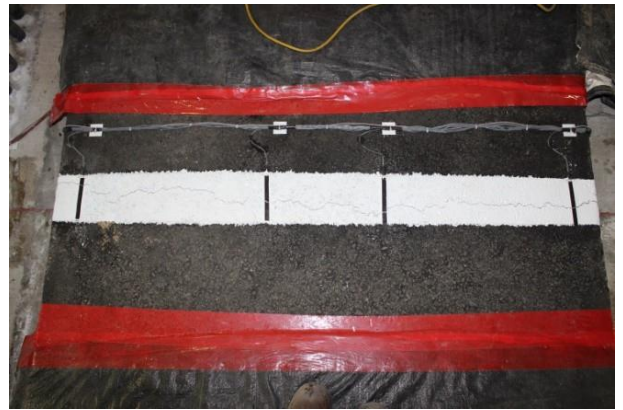
Figure 2. South surface crack complete.

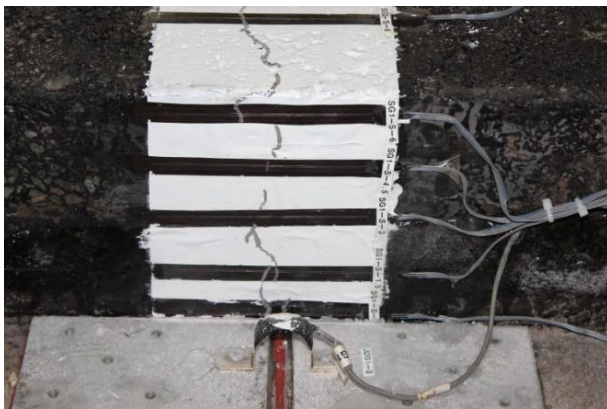
Figure 3. South inner vertical edge crack complete.

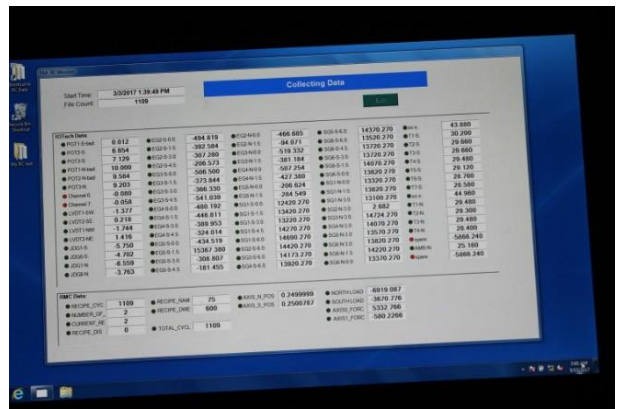
Figure 4. Data collection display showing open gauges.

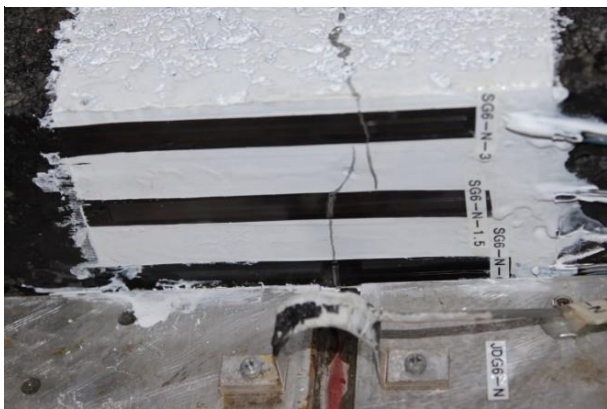
- Outer vertical edge:
 - No visual changes were observed.
 - The outer vertical edge is cracked as shown in Figure 5.
 - The 3 vertical edge gauges are open.
- Joint surface area:
 - The last bit of surface area just right of SG2-N-3 appears to be fully cracked as shown in Figure 6.
 - Three of the four surface gauges are reading open. SG2-N-3 remains intact because the crack occurred below the SG2-N-3 gauge.
 - This crack deviation could have been the results of two cracks coming together from opposite directions. The bottom up crack from the inner vertical edge and the surface crack that propagated from the North opposite side meet together below SG2-N-3 as shown in Figure 8.
- Inner vertical edge:
 - No visual changes were observed.
 - The inner vertical edge is cracked as shown in Figure 7.
 - The three vertical edge gauges are open.

Figure 5. North outer vertical edge crack complete.

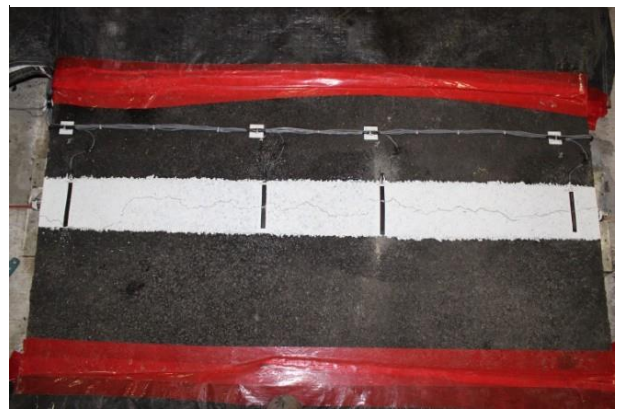
Figure 6. North surface crack complete.

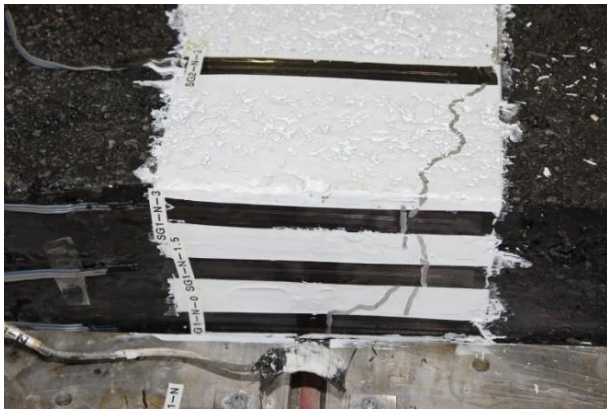
Figure 7. North inner vertical edge crack complete.

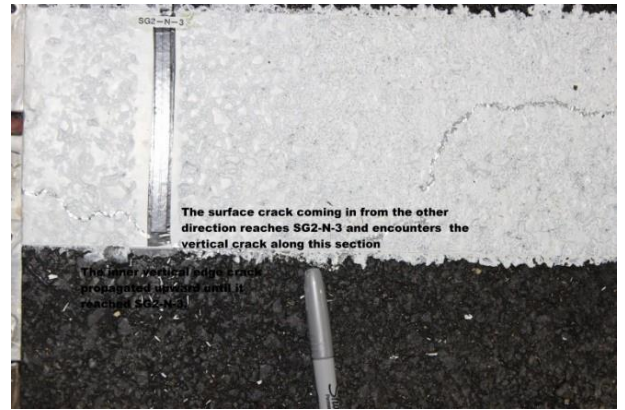
Figure 8. North surface area where the cracks meet.
